Serviceordre – Materiell

SERVICEORDRE – 2013-1

SERVICE BULLETIN #20121106

SUBJECT: "Reserve Staging Loop" with support washer. We (manufacturer) require the washer be removed. At the next scheduled repack cycle, remove the washer from the bungee staging loop and tie a double over-hand knot as instructed below and reinstall.

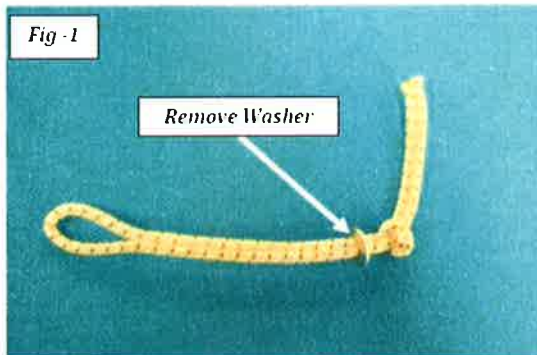
BACKGROUND: During recent inspections prior to repacking the reserve, extra normal wear was found on the reserve closing loop. Further investigation indicates that Vector systems fitted with a (bungee) "Reserve Staging Loop" with support washer may experience this problem. Some washers have sharp edges which had caused minor damage to the closing loop. Thus far, loop damage seen in the field following a 365-day repack cycle has not been considered serious, but is a concern. This Product Service Notification provides a safe solution without altering the function of the staging loop.

SERVICE BULLETIN: At the next scheduled inspection/repack cycle remove the support washer from the "Reserve Staging Loop." (Fig-1) Inspect the internal and external condition of the staging loop and replace it if any damage is found. Tie a "Double Over-Hand Knot" at the prescribed location. The staging loop length should be 1-inch (25mm) shorter than the reserve closing loop. Mark the loop at the desired length. Fig-2 shows a single over-hand knot. Fig-3 shows the loop end passing one more time through to create the double
