SERVICE BULLETINE – 2008- 1

SERVICE BULLETIN SB271107

ICON CONTAINER GROMMET INSPECTION Issue Date : November 27, 2007

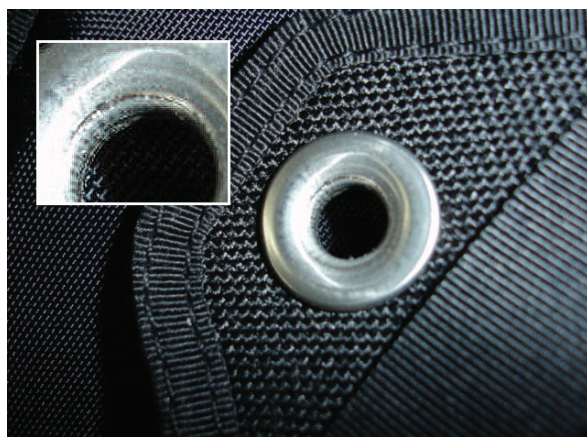
Background: A report back from the field revealed that there were some damaged Grommets on an ICON Container. The ICON was returned to the manufacturer where it was determined that the Grommets had been damaged by the Grommet Press.

The Damage can be seen on the inside of the Grommet where the Closing Tool has scratched the Inside Surface of the Grommet. The seating of the Grommet needs to be inspected to ensure correct and flush seating of the Grommet.

1. Damaged Grommet
see damage on inner ring of grommet

This could well be an isolated incident, but as a matter of precaution Aerodyne is recommending all Grommets on the ICONs listed in the Identification paragraph above be Inspected.

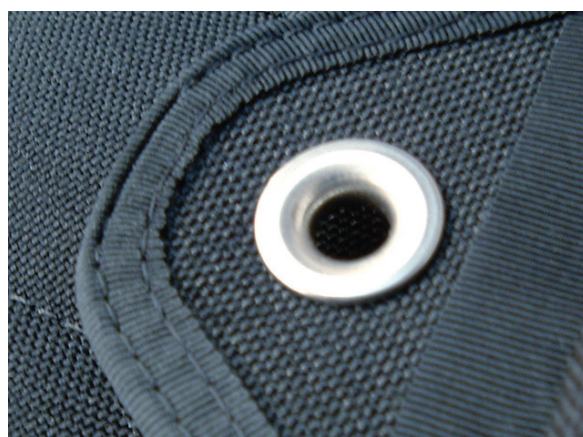
1. Undamaged Grommet
