## SERVICEORDRE – 2003-04

- HENVISNING:** Sun Path Inc.'s Manufacturer Product Service Bulletin Number SP02 (Vedlagt).
- FORMÅL:** Inspeksjon av feste for justeringsspenne på justerbare seletøy fra Sun Path Inc.

# Manufacturer Product Service Bulletin

## Number SP02

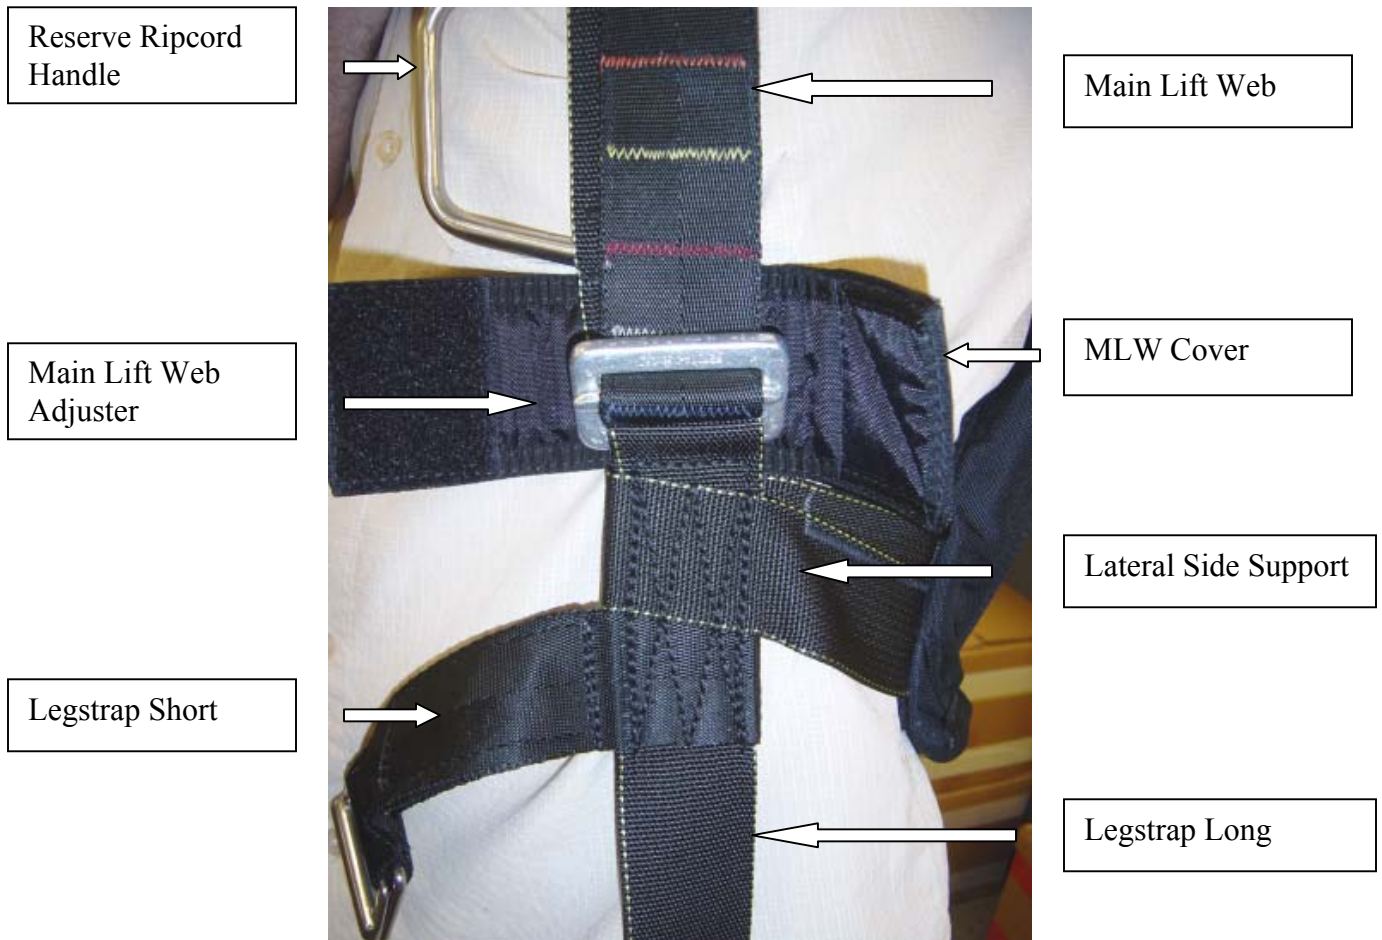
**Identification:** All Adjustable Main Lift Web Harnesses on Javelin and Javelin Odyssey harness/container systems, the majority being Student Systems. The Main Lift Webs (MLW) on the left and right side are threaded through adapters mounted just above the junction of the legstrap and lateral side supports. The Adjusters are primarily used for sizing of the MLW to better fit the user during use.

**Background:** Sun Path Products, Inc. has received notification of a MLW adjuster, used on a Student Javelin harness/container system, shearing through its securing webbing. This failure may or may not have resulted in a fatality.

Description of Identification (View shown is “ Wearer’s Left “)

**Inspection Requirement:** The webbing securing the adjuster in place at the junction of the legstrap and lateral side supports is to be inspected for wear and tear. If the webbing shows signs of fraying or abrasion that is inconsistent or appears to be excessive with what would be termed “normal wear”, the harness/container system is to be grounded and Sun Path Products, Inc. is to be contacted for further action
